Imagery Analysis Service Notes

12 April 1968

Present Status of the Hanoi Thermal Power
Plant 5

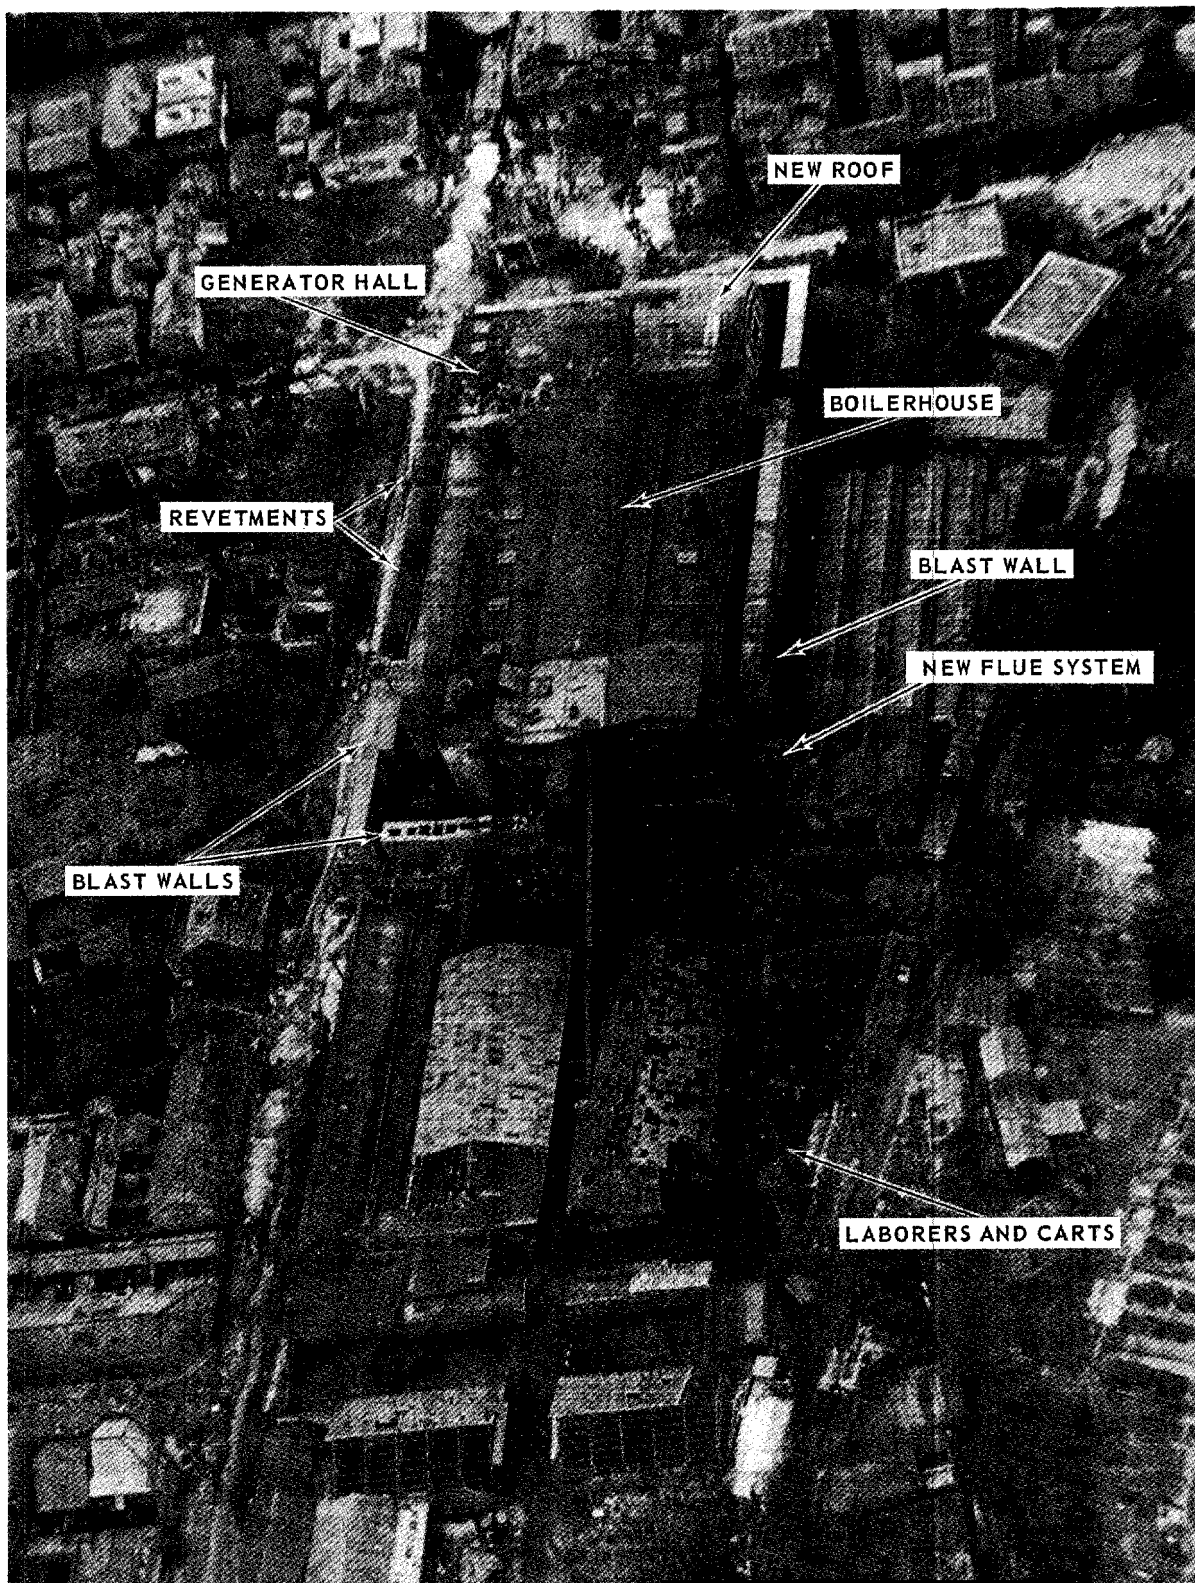
FIGURE 4. HANOI THERMAL POWER PLANT, [REDACTED]

Since it was last bombed on [] the Hanoi Thermal Power Plant has been repaired and the construction of heavy blast walls and new facilities has progressed rapidly (see Figure 4). As of [] the date of latest coverage, the plant appears capable of operating at about the same level as in [] at the outset of bombing.

Protective Measures. Additional blast walls and revetments have been constructed since [] and now nearly surround the boilerhouse and generator hall. Blast walls are being built along the north, south, and east sides of the boilerhouse. Each blast wall is about 10-15 feet thick, and consists of two walls separated by a space, as shown in the photograph. Previously, only two of the three exterior walls of the generator hall were so protected.

In addition, two wide revetments have been built south of the generator hall and boilerhouse to aid in protecting the plant.

The holes in the roof of the generator hall have been repaired since the last strike. About 40 percent of the generator hall is now covered by a new and higher roof, and it is likely that the entire roof will eventually be replaced.

A new addition to the plant is a flue system built to serve the northeastern boiler unit. This system is constructed so as to discharge the waste gases into the damaged section of the adjacent building. With this new flue system, a stack will not be required.

Repairs and New Construction. Repairs and new construction within the plant have been observed regularly since the outset of bombing. The amount of equipment and number of workers visible on the [] coverage indicate that work is continuing at a high pace.
